3.3 WATER RESOURCES

3.3.4 Tinian

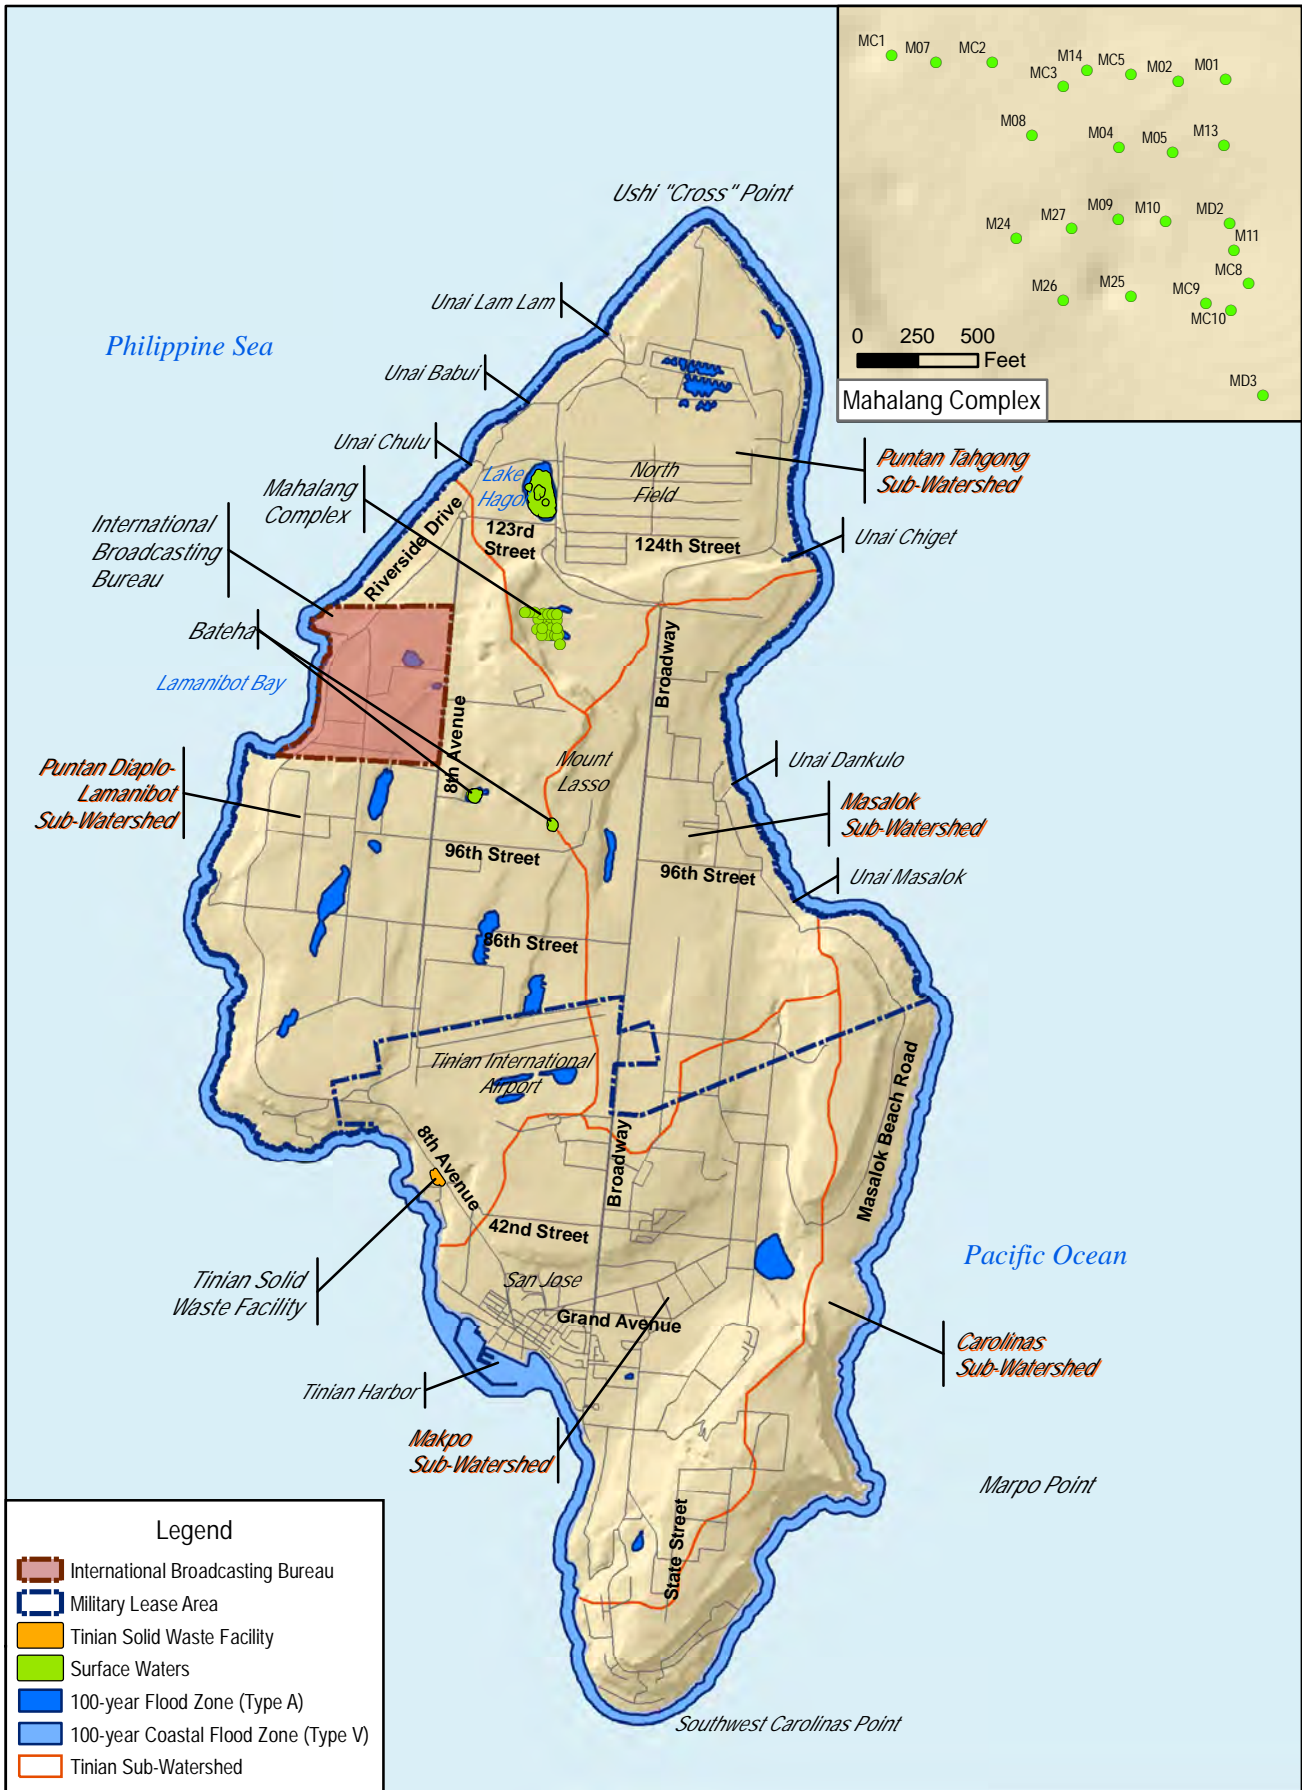
Figure 3.3-1
Tinian Surface Waters and Flood Zones

There are three known inland water features within the Military Lease Area ([Table 3.3-1](#) and [Figure 3.3-1](#)): (1) Lake Hagoi; (2) Mahalang Complex; and (3) Bateha Isolated Wetlands. Because Tinian is formed almost entirely of permeable limestone karst, there are few springs and no perennial (permanently flowing) streams. Drainage throughout most of Tinian is underground where rainwater generally percolates downward into porous rock (Doan et al. 1960), with the exception of during heavy rain events that occasionally result in stormwater runoff entering the surface and nearshore waters via short-lived ephemeral streams. Surface water features occur on Tinian in areas of impermeable clay that prevent infiltration of surface water, or at perched water tables (temporary pockets of groundwater located above unsaturated soil or rock, not connected to the permanent groundwater table). These areas are entirely dependent on rainfall as a water source for sustaining productivity and habitat quality.

from approximately 400 feet (120 meters) offshore to the shoreline cliff face or to the inland limit of primary flat sand beaches along open coastlines is designated as Flood Zone V and may be subject to storm-induced wave hazards. Tinian flood zones are shown in [Figure 3.3-1](#).

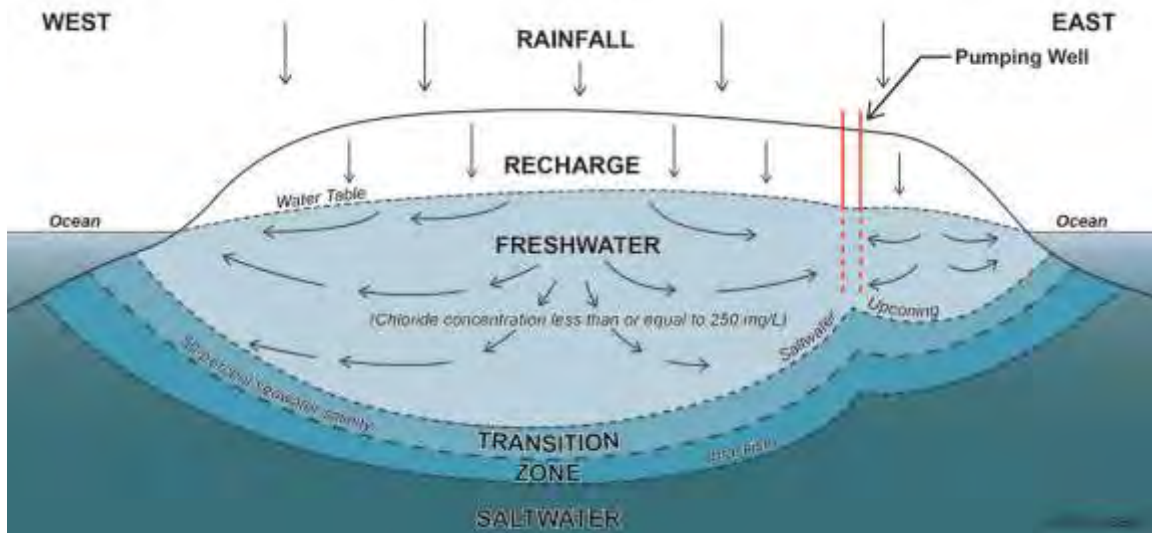
Figure 3.3-2 Graphic Depiction of a Freshwater Lens above a Saltwater Wedge – Standard, Vertical Pumping Well

Note: This figure is intended as a simple representation of interface between the freshwater and saltwater.

Rainfall percolates rapidly downward into porous limestone rock and is the primary recharge source of fresh groundwater on Tinian (Doan et al. 1960). The average annual groundwater recharge for Tinian is estimated to be about 30 inches (76 centimeters) per year (Gingerich 2002). Groundwater is plentiful in Tinian's basal groundwater lens (lenses of fresh groundwater that floats on top of denser saltwater below) (Doan et al. 1960). This freshwater, Ghyben-Herzberg groundwater lens (fresh water that "floats" on top of saltwater forming a profile that has the appearance of a lens) is in both limestone and volcanic rocks, with the most important sources coming from limestone formations (Gingerich 2002). The interface between the freshwater and saltwater is a transition zone at a depth below sea level ([Figure 3.3-2](#) and [Figure 3.3-3](#)). The portion of the lens that is used for potable water (i.e., with chloride concentrations less than 250 parts per million) is thickest in the North-Central Highland and Central Plateau and grows increasingly thinner approaching the coastline. See Appendix P, *Utilities Study*, for additional information about the Ghyben-Herzberg lens relationship. Tinian geologic units including Mariana and Tagpochau limestones are shown in Section 3.2, *Geology and Soils*, [Figure 3.2-3](#). The freshwater lens extends from a maximum recorded 3.42 feet (1.04 meters) above MSL to about 140 feet (42 meters) below MSL at its deepest point (Gingerich 2002). Groundwater table elevation contours and the general direction of groundwater flow are shown in [Figure 3.3-4](#).

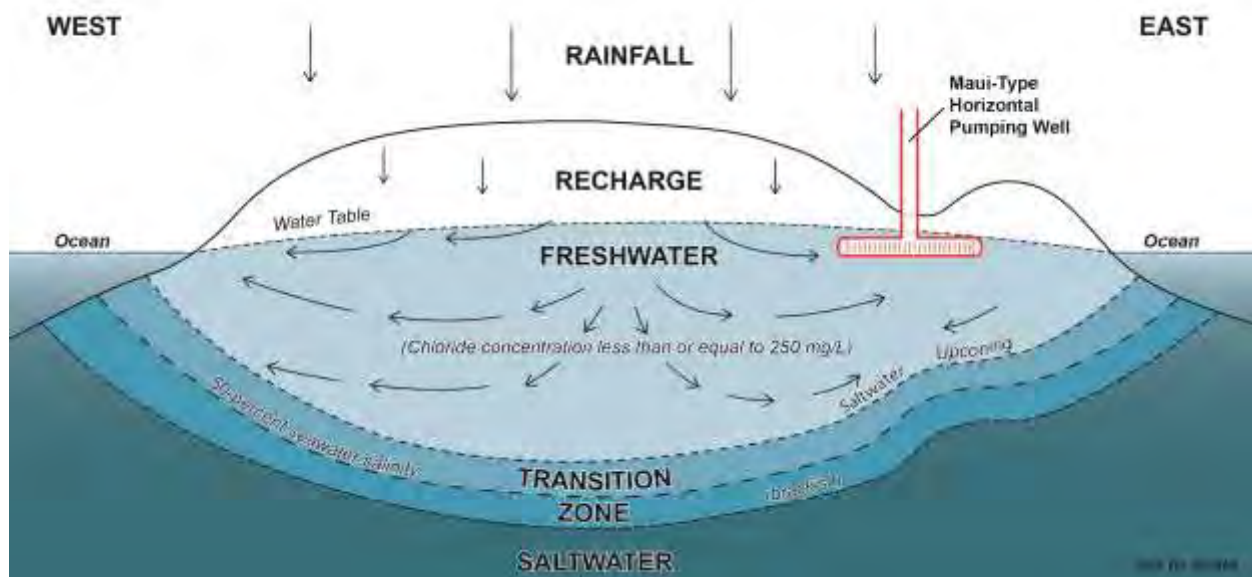
Figure 3.3-3 Graphic Depiction of a Freshwater Lens above Saltwater Wedge – Horizontal, Maui-Type Pumping Well

Note: This figure is intended as a simple representation of interface between the freshwater and saltwater.

[Figure 3.3-4](#) shows the locations of known groundwater wells. The Commonwealth Utilities Corporation public system extracts water from one horizontal Maui-type well (Maui Well #2) located in the Makpo sub-watershed (a Maui-type well has a horizontal collector trench constructed near the top of the water table). Before Maui Well #2 was put into service, the public system extracted water from Maui Well #1. Maui Well #1 is currently out of service due to old equipment and difficulty obtaining repair parts. See Appendix P, *Utilities Study*, for additional information on Tinian’s public water system and discussion of the sustainable yield (the rate at which groundwater can be continuously withdrawn from an aquifer without impairing the quality or quantity of the pumped water or the environment) of Tinian’s aquifers. In addition to pumping from Maui Well #2 for the public water system, water is currently pumped from two wells (rehabilitated by a private party) to fill containers for providing water to cattle, labeled M21 and M26 in [Figure 3.3-4](#).

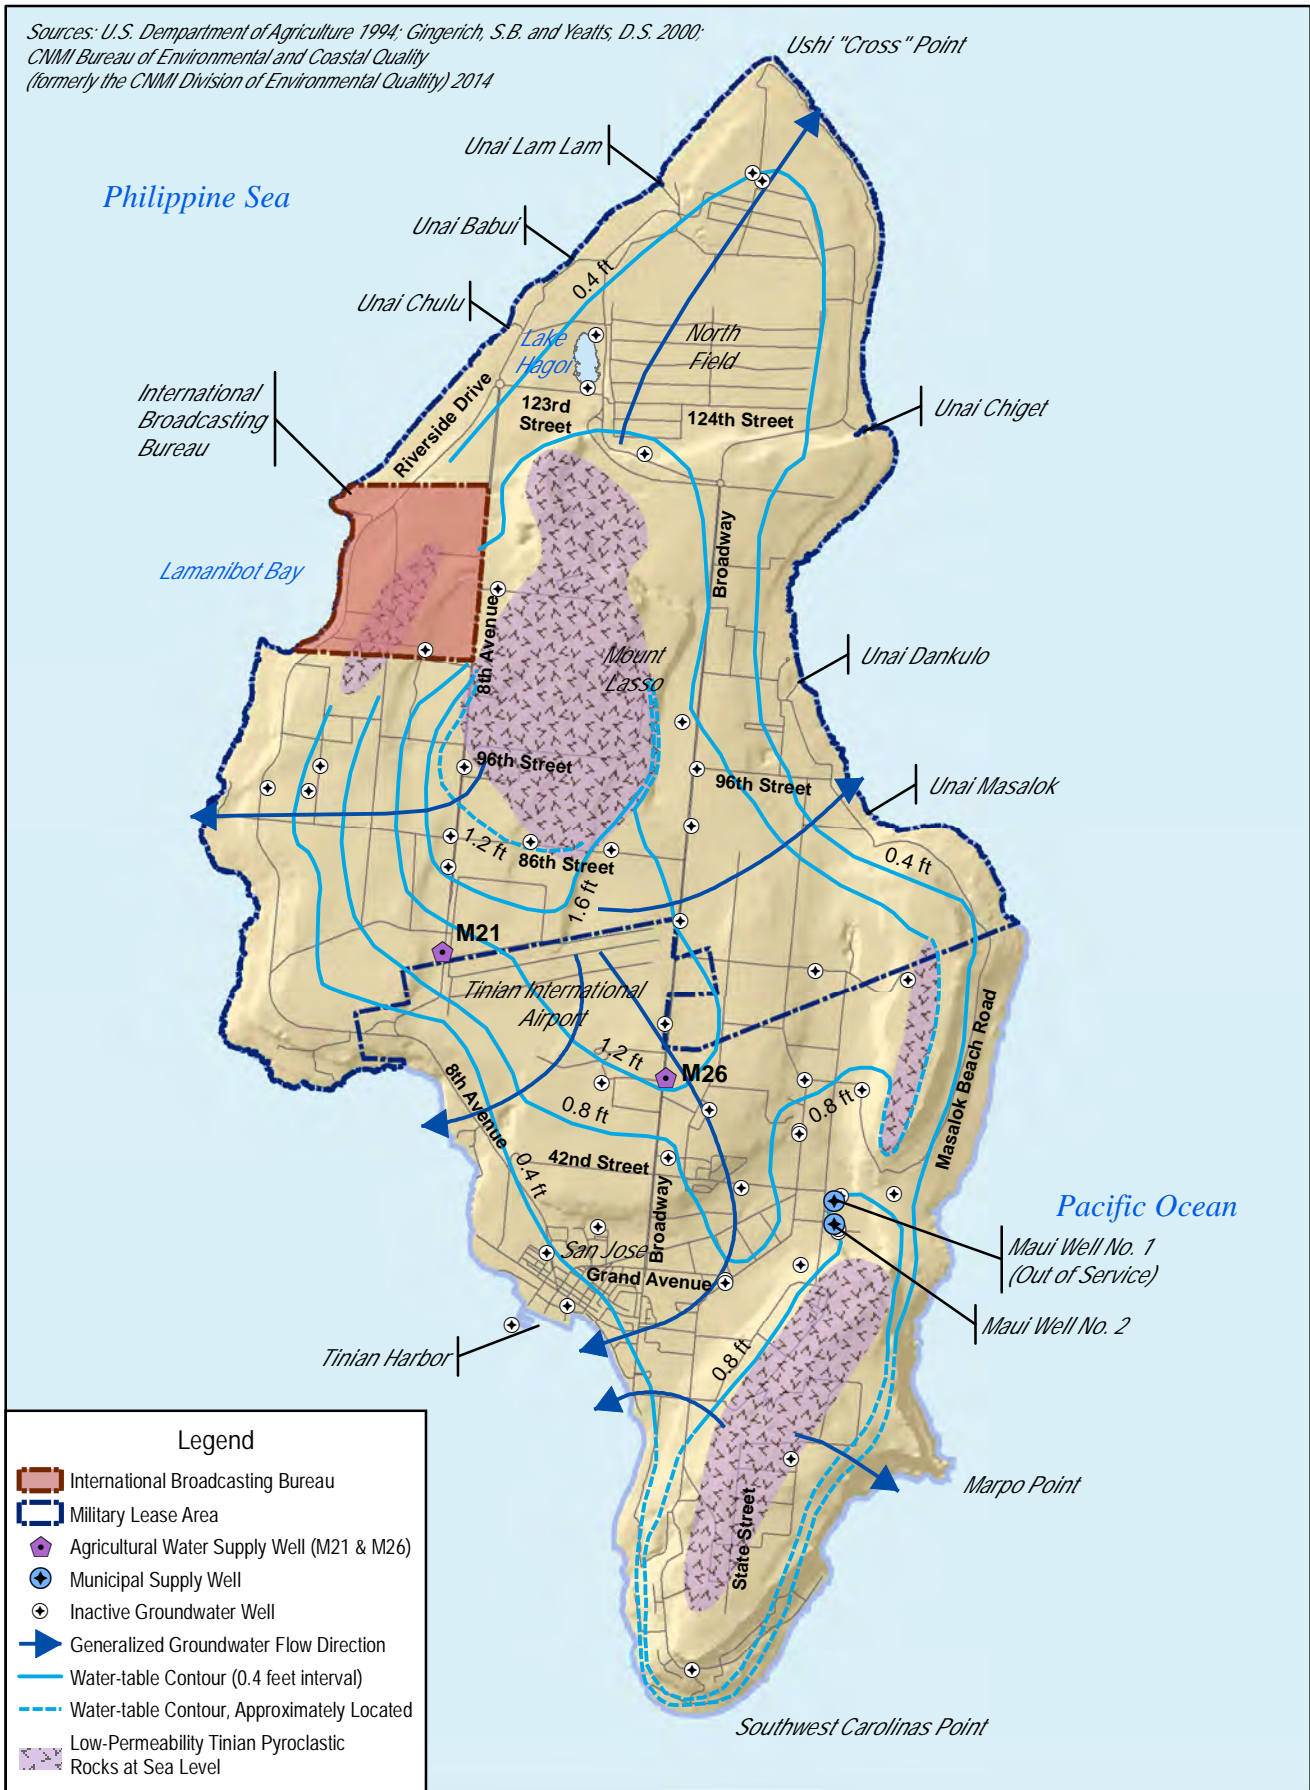
Figure 3.3-4
 Tinian Groundwater Wells, Elevation, and Flow Direction

- International Broadcasting Bureau
- Military Lease Area
- Agricultural Water Supply Well (M21 & M26)
- Municipal Supply Well
- Inactive Groundwater Well
- Generalized Groundwater Flow Direction
- Water-table Contour (0.4 feet interval)
- Water-table Contour, Approximately Located
- Low-Permeability Tinian Pyroclastic Rocks at Sea Level

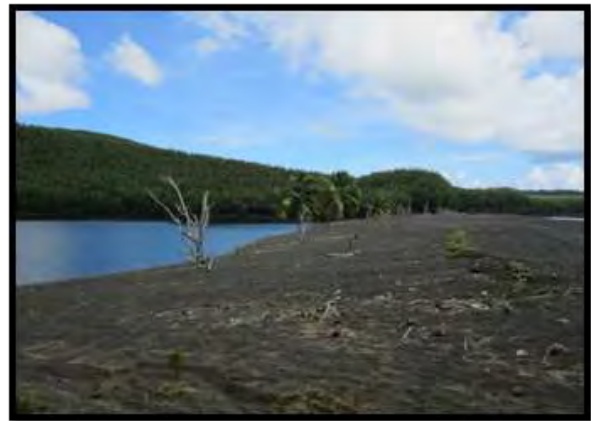
Photo 3.3-1. Laguna Sanhiyon and Sand Bar Separating the Lake from the Ocean

Laguna Sanhiyon (commonly known as Lower Lake) is an approximately 40-acre (16-hectare) brackish water lake on the western shore. The lake has a maximum depth of approximately 65 feet (20 meters) (CNMI Office of Transition Studies and Planning 1978). A sand bar composed of marine tuffs and basaltic sand separates the lake from the ocean (Photo 3.3-1). During storms, waves occasionally over top the sand bar (CNMI Office of Transition Studies and Planning 1978). A small tidally mediated freshwater wetland area is located on the north end of Laguna Sanhiyon (Polhemus 2010).

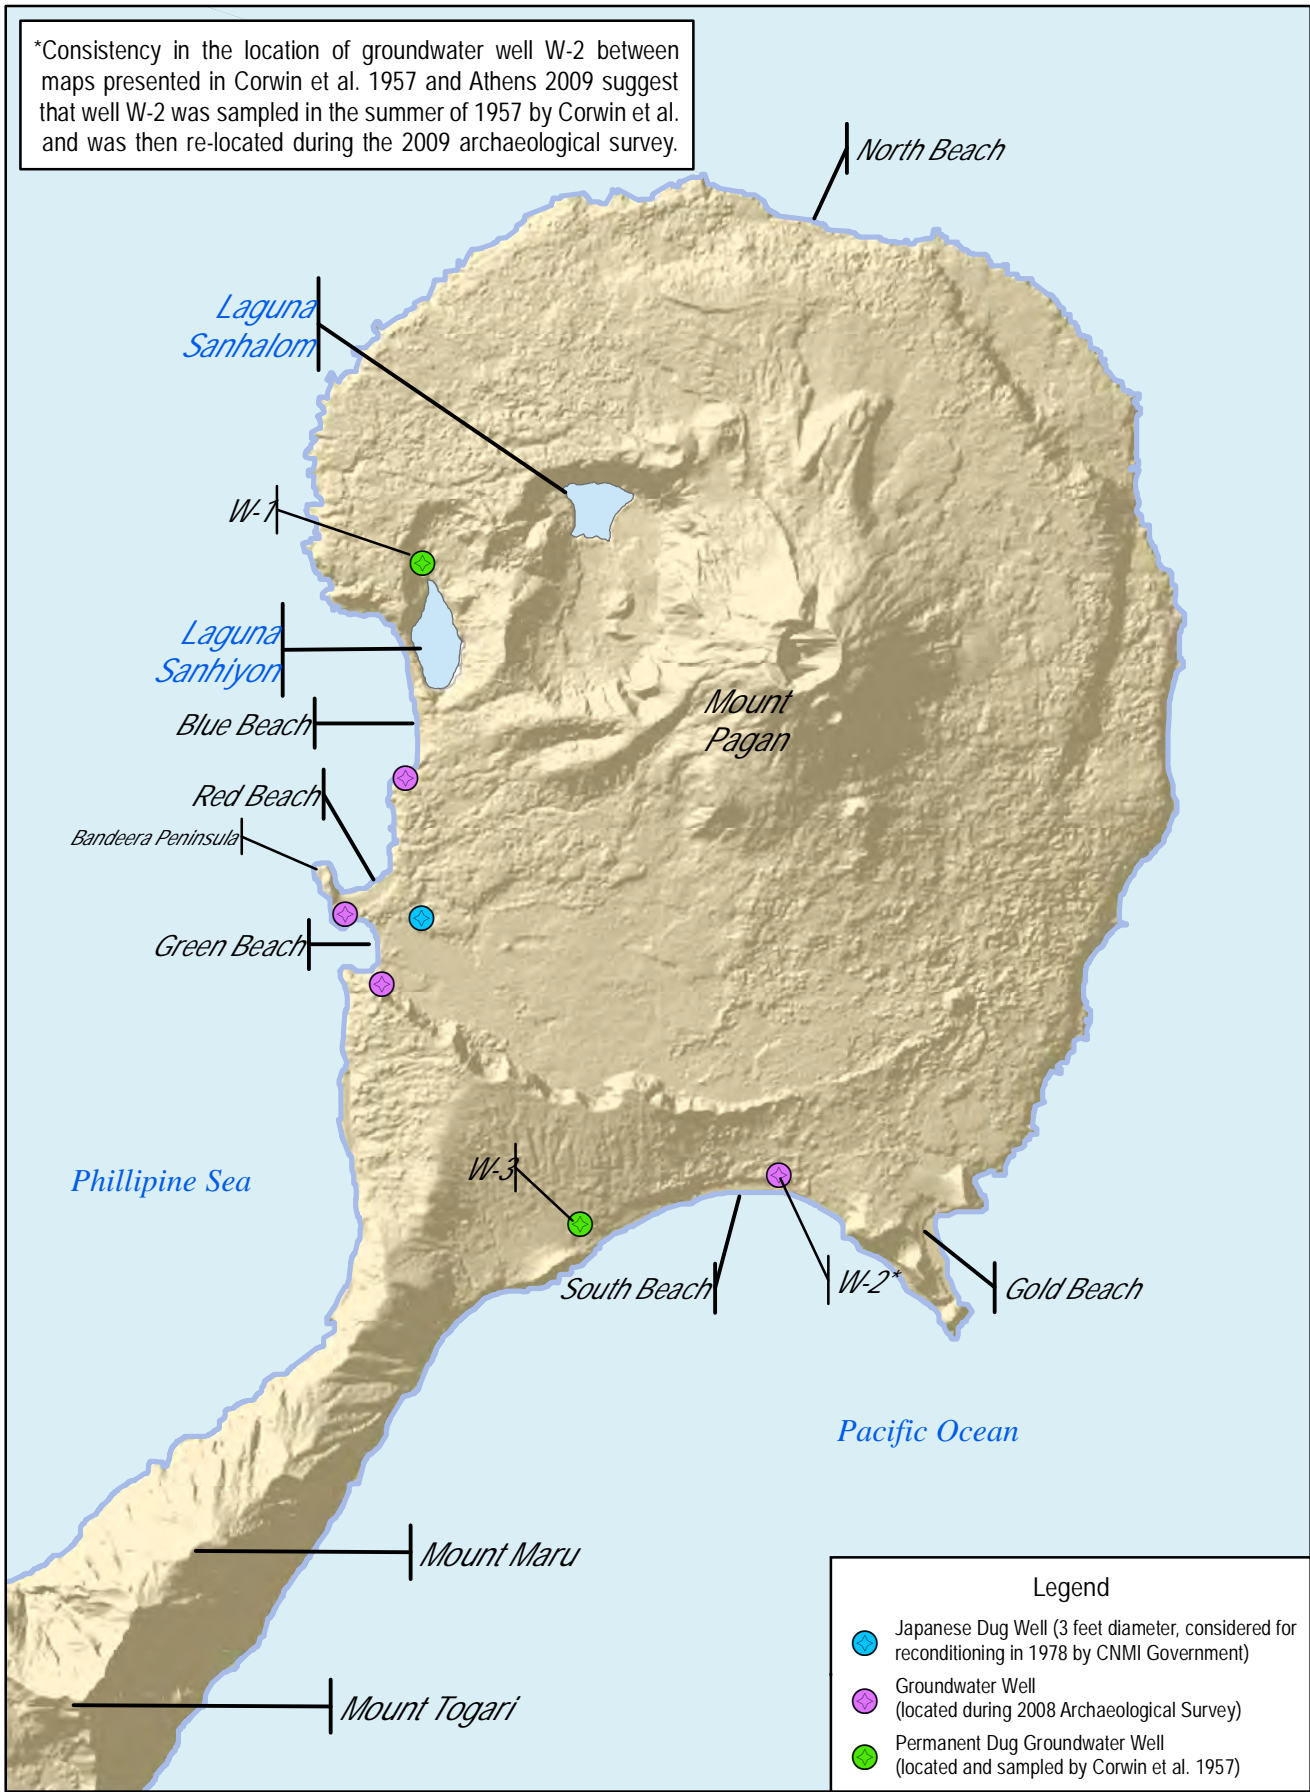
Figure 3.3-5
Pagan Surface Waters and
Groundwater Well Locations

- Japanese Dug Well (3 feet diameter, considered for reconditioning in 1978 by CNMI Government)
- Groundwater Well (located during 2008 Archaeological Survey)
- Permanent Dug Groundwater Well (located and sampled by Corwin et al. 1957)

Average annual rainfall on Pagan is 70 to 80 inches (178 to 203 centimeters). Surface water features on Pagan include two lakes: Laguna Sanhiyon and Laguna Sanhalom, shown in [Figure 3.3-5](#), and springs found across the island. There are no permanent rivers or streams on the island. Though surface water drainage has not been studied, it is thought that most of the infiltrating rainwater percolates rapidly to a large basal fresh groundwater body; however, no testing has been conducted to confirm this (CNMI Office of Transition Studies and Planning 1978).

Other potential sources of potable water are within the volcanic rock of the plains surrounding Mount Pagan, because of the high rates of infiltration and rapid circulation through the rocks. [Figure 3.3-5](#) shows the location of the known groundwater wells on Pagan: a former Japanese well located north of the Japanese runway, four wells identified during a 2008 archaeological survey (CNMI Office of Transition Studies and Planning 1978; Athens 2009), and two additional wells located and sampled by Corwin et al. (1957). The wells are subject to saltwater intrusion and their current status is unknown (DoN 2013b).

along Green Beach (see [Figure 3.3-5](#)) relative to the other leeward beaches. Kitchen scraps found in shallow sediments of the bay at Green Beach during coral surveys suggests that use of the area by visitors to Pagan could also potentially influence nearshore water quality (DoN 2014).
